**Appendix F.3c**  
**Hazardous Materials Investigation and Findings**  
**Reports**  
**(February 2022)**

LIMITED HAZARDOUS MATERIALS INVESTIGATION REPORT  
NORTH/WEST BATTERY PARK CITY RESILIENCY PROJECT  
NEW YORK, NEW YORK

Matrix No. 20-1152

February 23, 2022

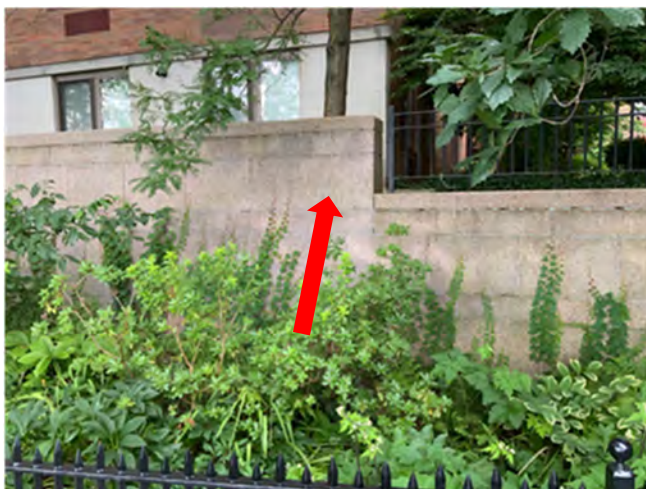
**PHOTO 3**

**LOCATION:** South Cove Park Between 2<sup>nd</sup> and 3<sup>rd</sup>

**MATERIAL:** Retention Wall Mortar

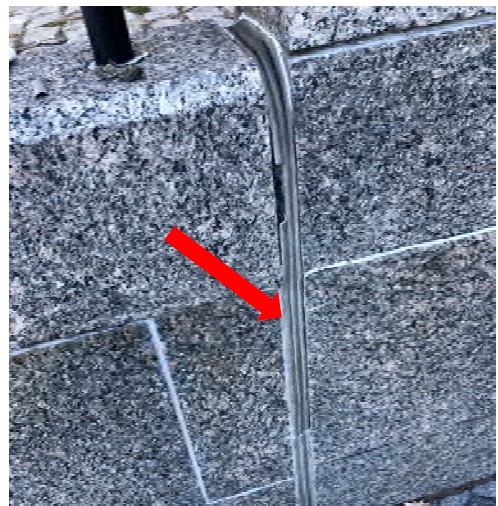
**PHOTO 6**

**LOCATION:** South Cove Park Between 2<sup>nd</sup> and 3<sup>rd</sup>

**MATERIAL:** Caulk to Retention Wall

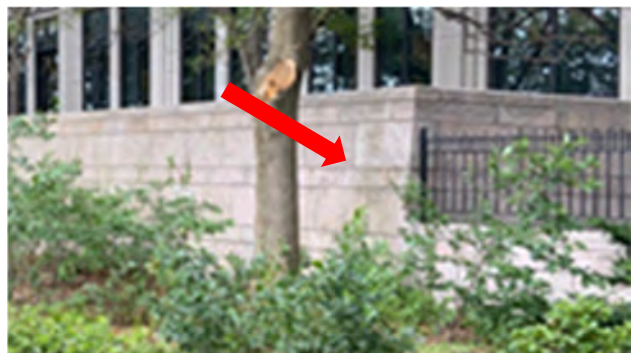
**PHOTO 8**

**LOCATION:** South Cove Park Esplanade Plaza  
Adjacent to Thames Street

**MATERIAL:** Retention Wall Caulk

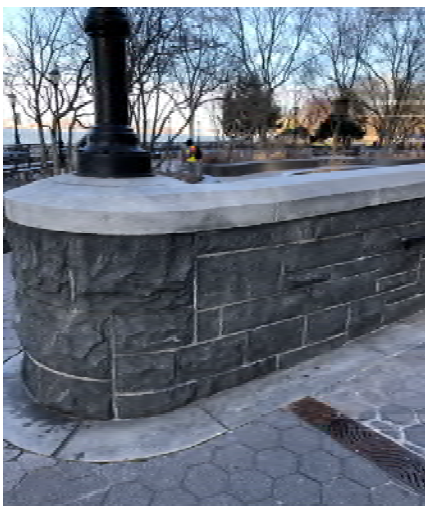
**PHOTO 15**

**LOCATION:** Rockefeller Park

**MATERIAL:** Mortar to Stone Wall
